Watershed Specialist Report Boulder Project

Prepared by: */s/ Kyle E. Wright* Date: *10/24/12*
Kyle E. Wright, Hydrologist
Sequoia National Forest and Giant Sequoia National Monument

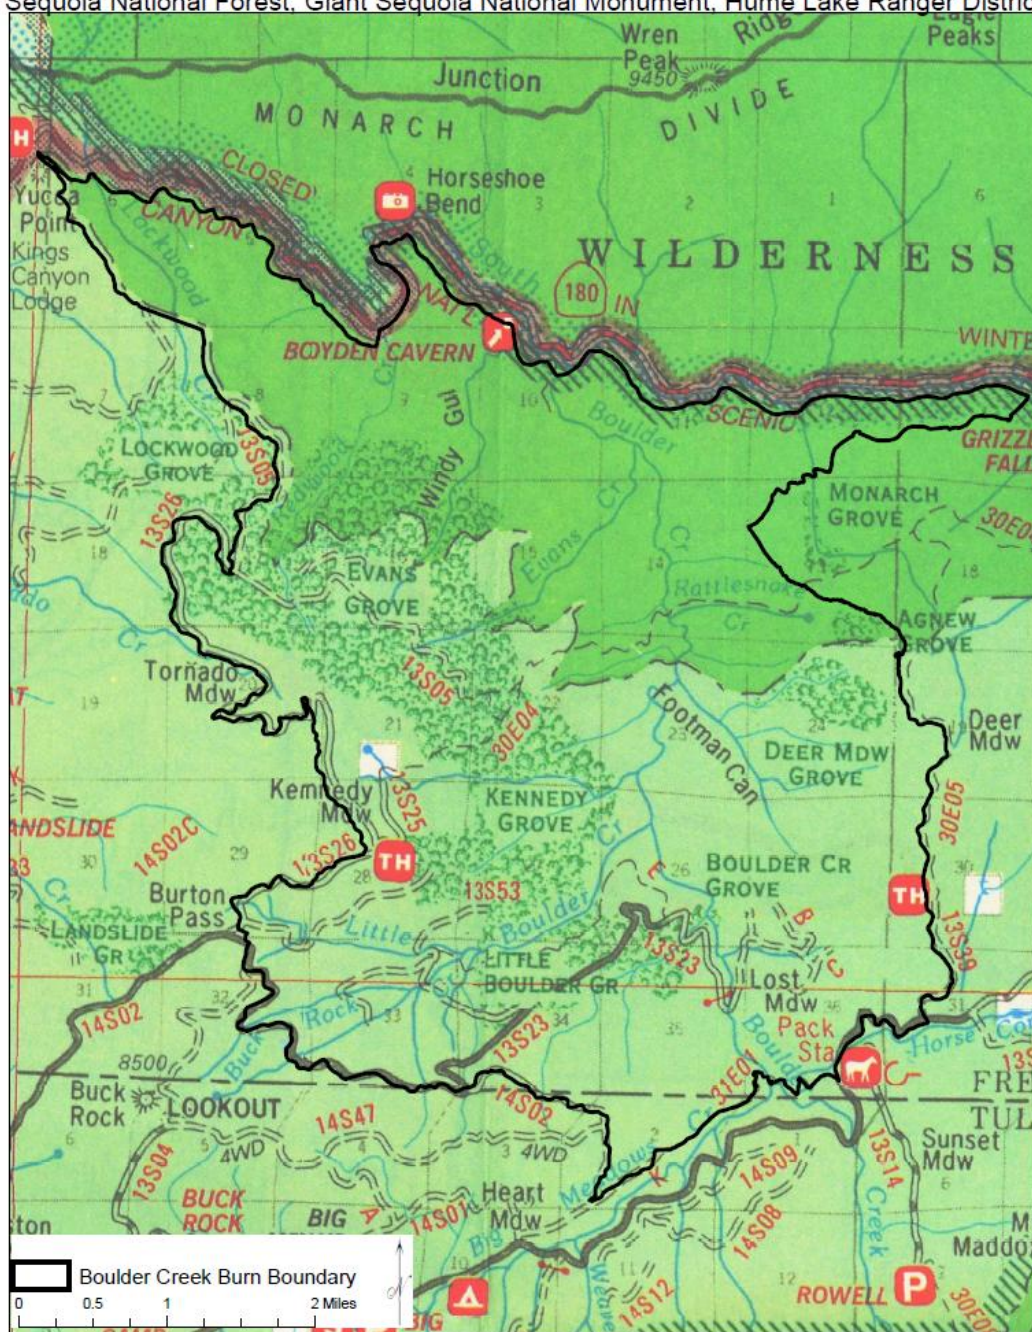
Figure 1: Boulder Project Area Map

There are four 6th field watersheds affected by the Boulder Burn Project. Figure 1 shows a map of the proposed area. Ninety-Five percent of the project is within South Fork Kings River/Lower Boulder watershed (180300100304). The remaining five percent is within South Fork Kings River/ Lightning Creek (180300100302), Tenmile Creek (180300100501), and Upper Boulder Creek (180300100303). Only South Fork King River/ Lower Boulder would be further analyzed for the affected environment. Table 1 displays the stream class, beneficial uses and acres of South Fork King River/ Lower Boulder watershed.

Boulder Burn Project Map, Hydrology
 Sequoia National Forest, Giant Sequoia National Monument, Hume Lake Ranger District

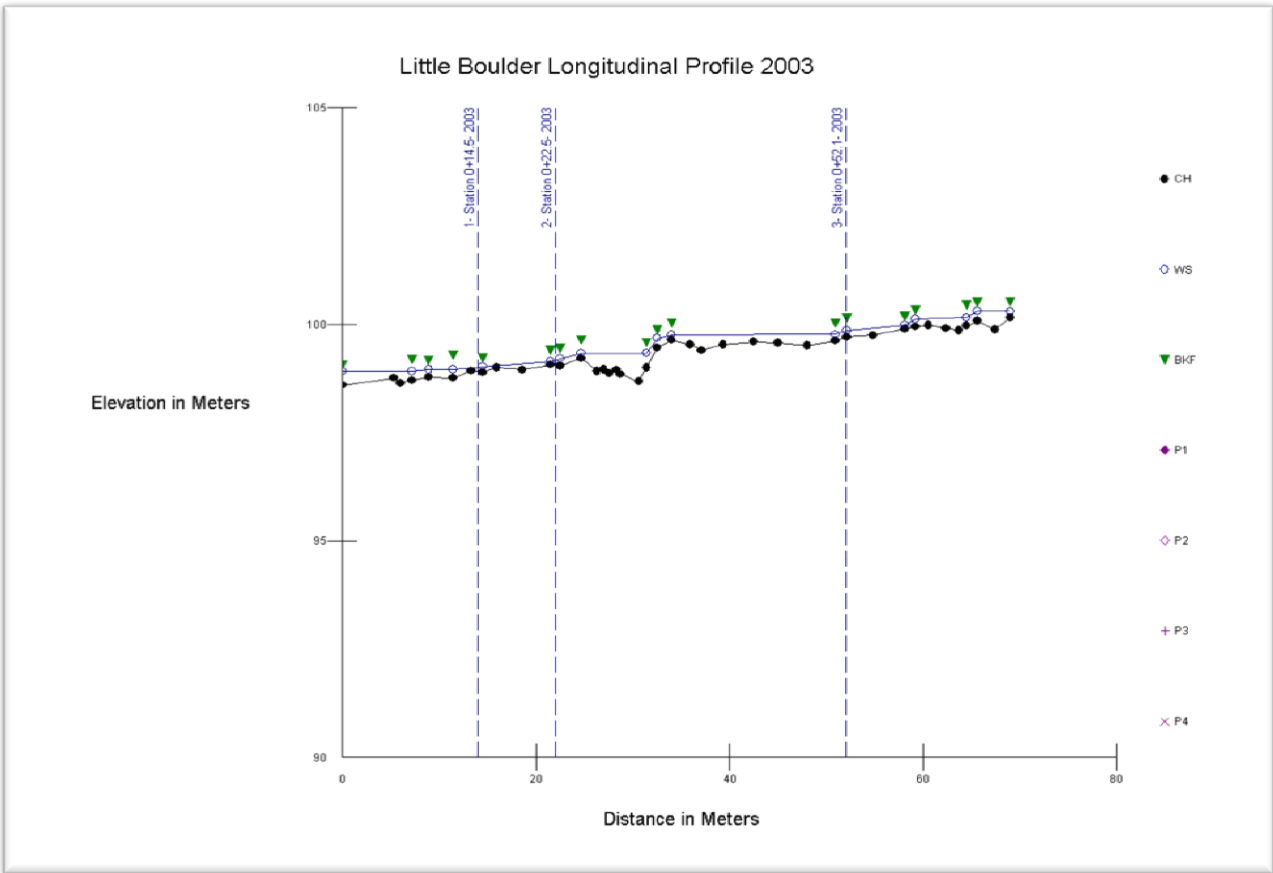
Figure 2- 2003 Longitudinal Profile of Little Boulder Creek

A Longitudinal profile is provided to show cross section locations and an overview of the habitat types in Little Boulder Creek. Subsequent surveys repeat cross section surveys and other metrics; however unless the site has been affected by a fire, flood or other catastrophic event the longitudinal profile is not resurveyed. Little Boulder Creek was surveyed in 2003, 2004, and 2012. Review of the survey indicated that it represents the current condition of the study reach. Figure 1 displays the 2003 longitudinal profile for Little Boulder Creek and location of cross sections.

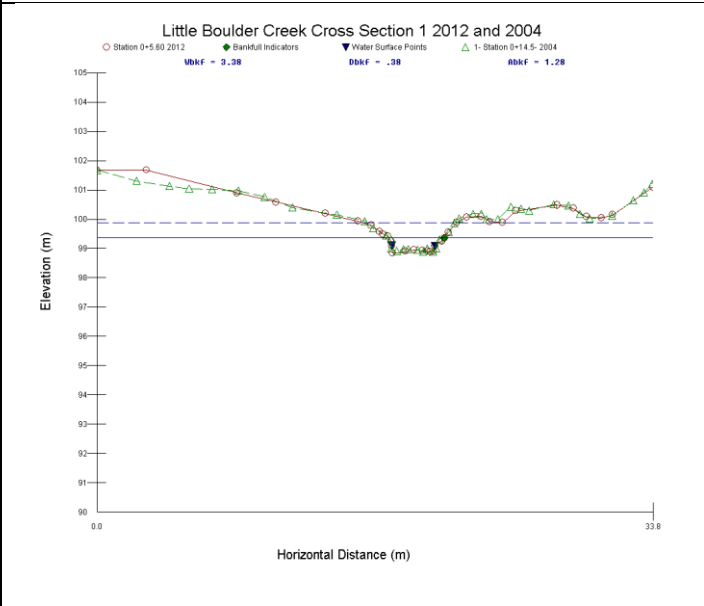
Figure 3 Cross-Section 1 Little Boulder Creek

Cross sections were repeated for all survey years. Cross section 1, 2, and 3 illustrate the consistent conditions in the reach. Cross sections and particle counts are shown in figures 3-6.

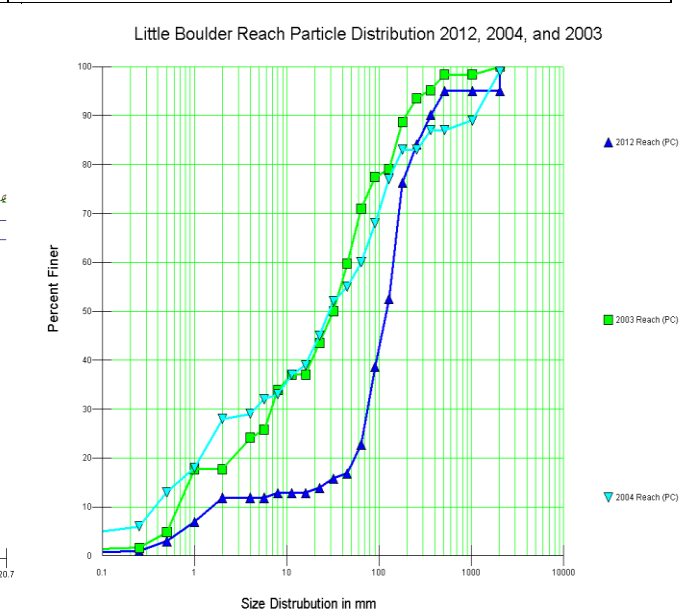
Figure 6 Reach Particle Distribution Little Boulder Creek

Particle distribution of channel bottom material for Little Boulder Creek is provided in figure 5. Particle distribution for Boulder Creek indicates a coarsening of channel bottom material from 2003/4 to 2012 indicating less deposition of fine material.

It appears as if Little Boulder Creek has improved habitat conditions since the initial surveys of 2003/2004. Channel type has not changed and remains a B4 channel type (Rosgen, 1994). Pfankuch Stability evaluations indicate a transition from fair to good stability.

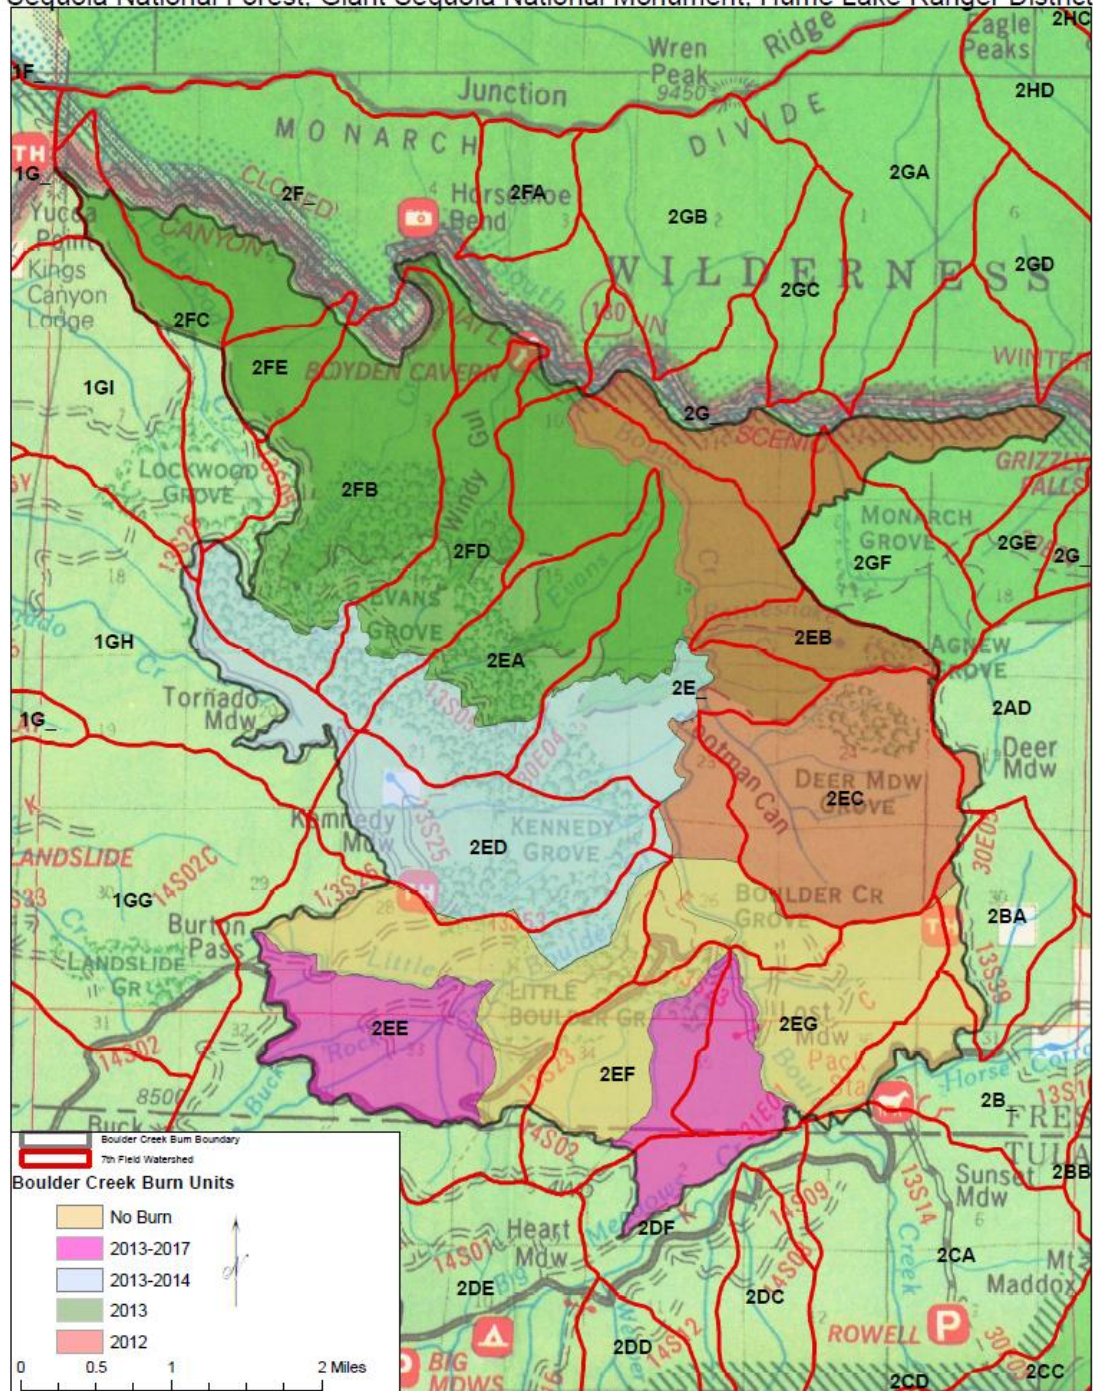
Figure 7- Map showing HUC 7 Watersheds and Proposed Burn Units by Year

The Forest Service proposes to use prescribed fire to reintroduce fire into the lower portion of the Boulder Creek drainage. The project area encompasses approximately 14,385 acres of the watershed, of which 6,000 to 9,000 acres would be proposed for underburning (see Figure 7). The smaller amount of treatment acres is due to large areas of rock and other features that would need other treatments prior to, or instead of, prescribed fire.

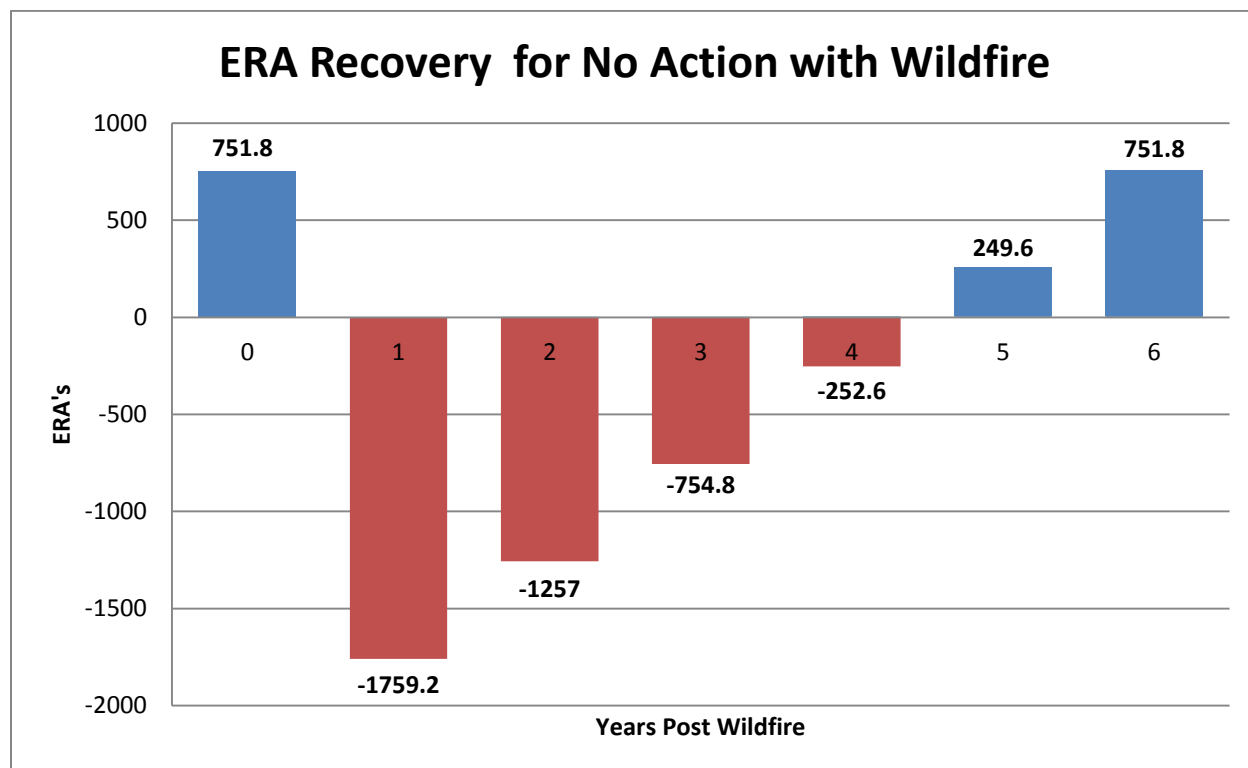
Figure 7: No Action Alternative with Wildfire ERA recovery

The No Action Alternative with Fire would have a higher potential to effect water quality, stream stability temperature and soil loss. Wildfire has an estimated effect of 0.27era/acre (Draft Monument Plan, 2012). Figure 7 and Table 4 show the potential effects of a wildfire within the project area. Figure 7 below analyses the 9,300 acre area proposed for the Bolder Burn Project as a wildfire. The effect of a wildfire of this magnitude would result in a dramatic leap into negative EAR's. . The result of a wildfire within the proposed project area would increase the potential for detrimental effects to watershed health. As analyzed, ERA's change from 751.8 to -1759.2 as a result of a wildfire in the project area.

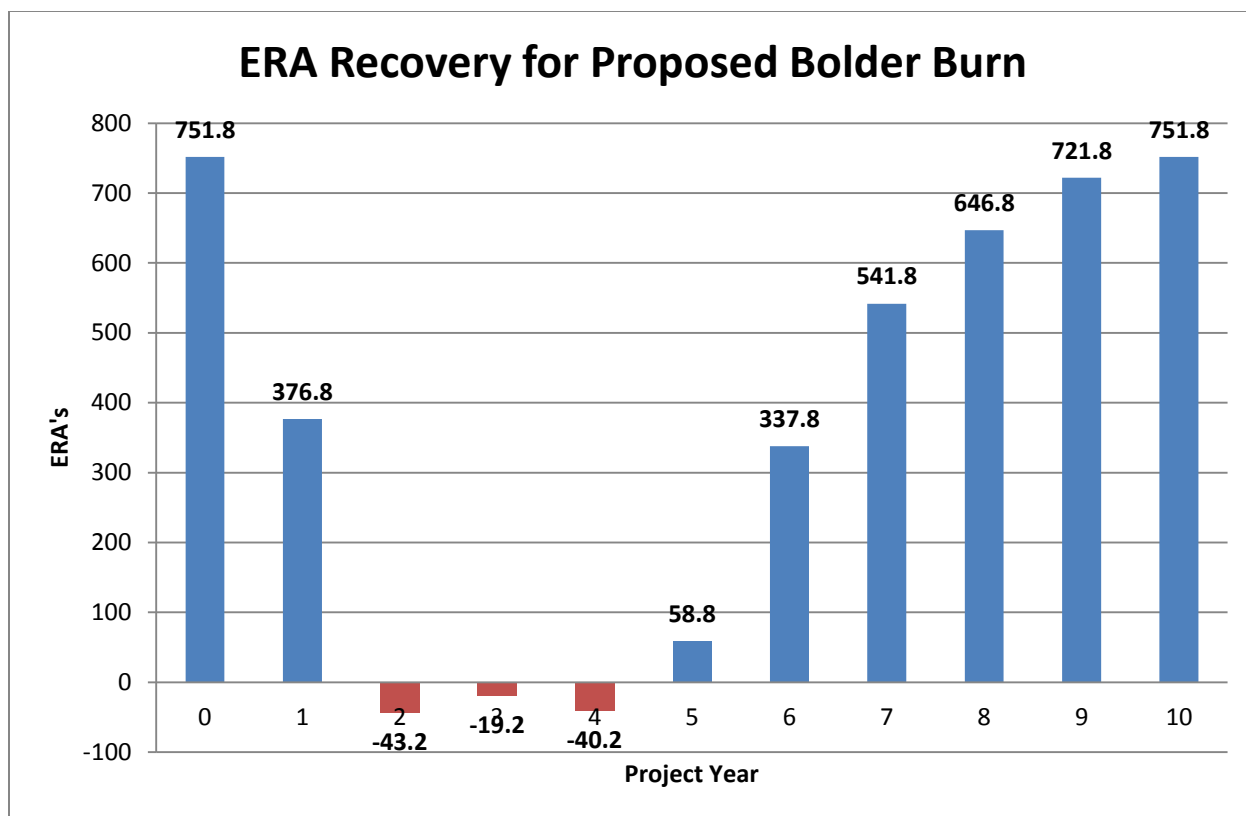
Figure 8: Proposed Action with ERA recovery

The proposed activity increases the potential for watershed effects slightly above threshold during the project timeframe. This is shown in Figure 8 and Table 5. Despite the potential increase for cumulative effects, watershed health is expected to be enhanced as a result of the project and provide more resiliencies in its potential for future fires. Ash and potential sediment that does reach the channel is expected to be flushed out, especially in the channels closer to the King's River that are bedrock controlled. The nearby Sheep Wildfire in 2010 produced sediment and ash into the Kings River, but now with increased groundcover in 2011, there is much less noticeable sediment runoff. With the ability to prescribe fire to meet specific constraints concerning attributes such as size, relative humidity, ignition sites, avoidance areas, and wind direction, watershed integrity can be maintained throughout the project. It is expected that the project would recover to above threshold five years following implementation and completely recover back to pre-project conditions ten years following implementation.

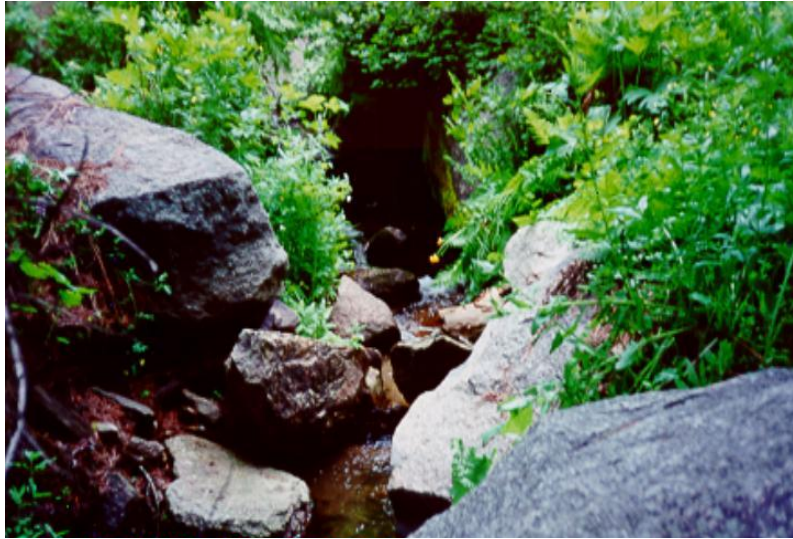
Figure 1. Naturally Stable Riparian Ecotype

This ecotype is inherently stable and comprised of bedrock, boulder and cobble controlled channels. It is not significantly influenced by land management activities. Sediment build-up can be concerns in some locally impacted areas. Figure 1, Scarlet and Davis Creek is an example of a Naturally-Stable riparian ecotype.

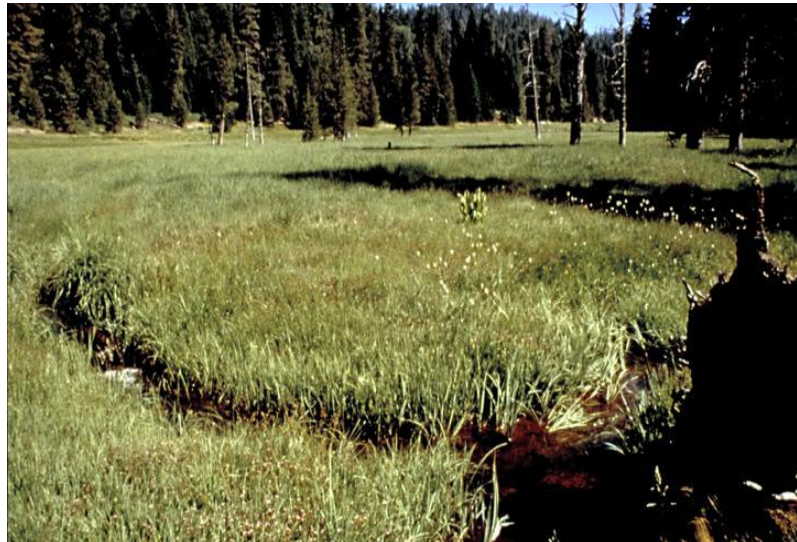
Figure 2. Stable Sensitive Riparian Ecotype

This ecotype is inherently stable dominated by cobble, gravel, sand, and finer material. It is located in relatively flat riparian areas that are easily influenced by land management activities. This ecotype is comprised of streams typically associated with meadows with or without defined channels. This ecotype is stable and very susceptible to disturbances and changes in the flow, timing, and quality of water. Figure 2, Horse Meadow Creek is an example of a Stable-Sensitive riparian ecotype.

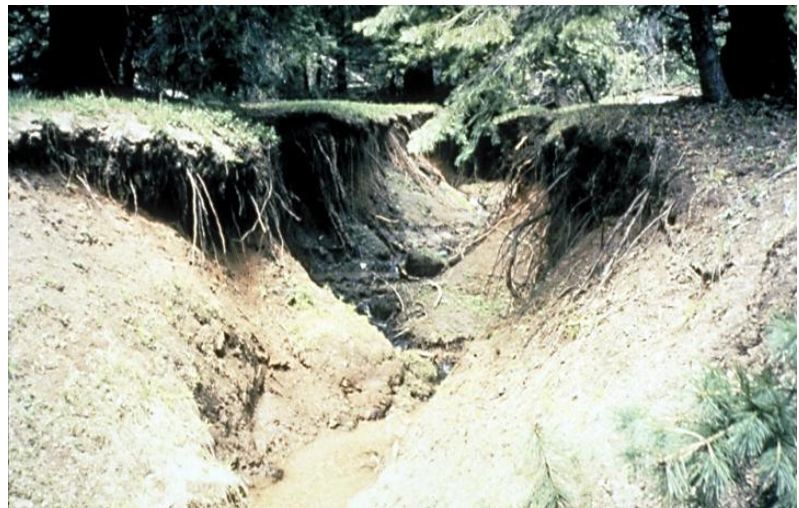
Figure 3. Unstable-Sensitive Degraded Riparian Ecotype

This ecotype has been degraded and represents severe alteration of another riparian ecotype. In most

cases, this ecotype represents the degraded form of Stable-Sensitive ecotypes that were formerly meadows. These ecotypes are comprised of down cut meadows with lowered water tables and abandoned flood planes. Meadow functions are not operating and vegetation is comprised of species that represent dry sites; accelerated erosion is common. A less common form of this ecotype is the altered form of the Naturally-Stable ecotype resulting from extensive accelerated sediment deposition on a coarse substrate. These areas exhibit braided characteristics the source of which is usually associated with upstream sites and/or deposition from off-site sources of sediment (roads, trails, campgrounds etc.) that has been transmitted to the site. Recovery usually requires active restoration measures. Figure 3, Tributary to Packsaddle is an example of a Naturally-Unstable-Degraded riparian ecotype.

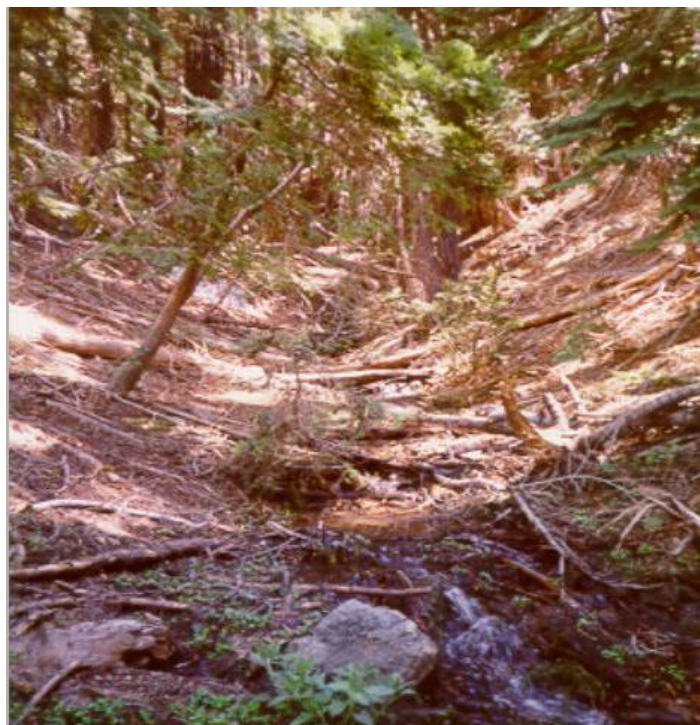
Figure 4. Naturally Unstable Riparian Ecotype

This ecotype is typically eroded, steep, and unstable due to natural processes. It has a very high sediment load and is usually associated with debris avalanche or landslide terrain. These environments are sensitive to disturbance, and restoration is not practical due to a natural tendency for unstableness. Figure 4, Mill Creek is an example of a Naturally-Unstable riparian ecotype and is geomorphically described as a debris basin.
